BUREAU OF SHIPS GROUP
TECHNICAL INSPECTION REPORT

⑥ OPERATION CROSSROADS.
U.S.S HUGHES (DD410).
TEST BAKER.

VOLUME II [u] ⑧

USS HUGHES (DD410)

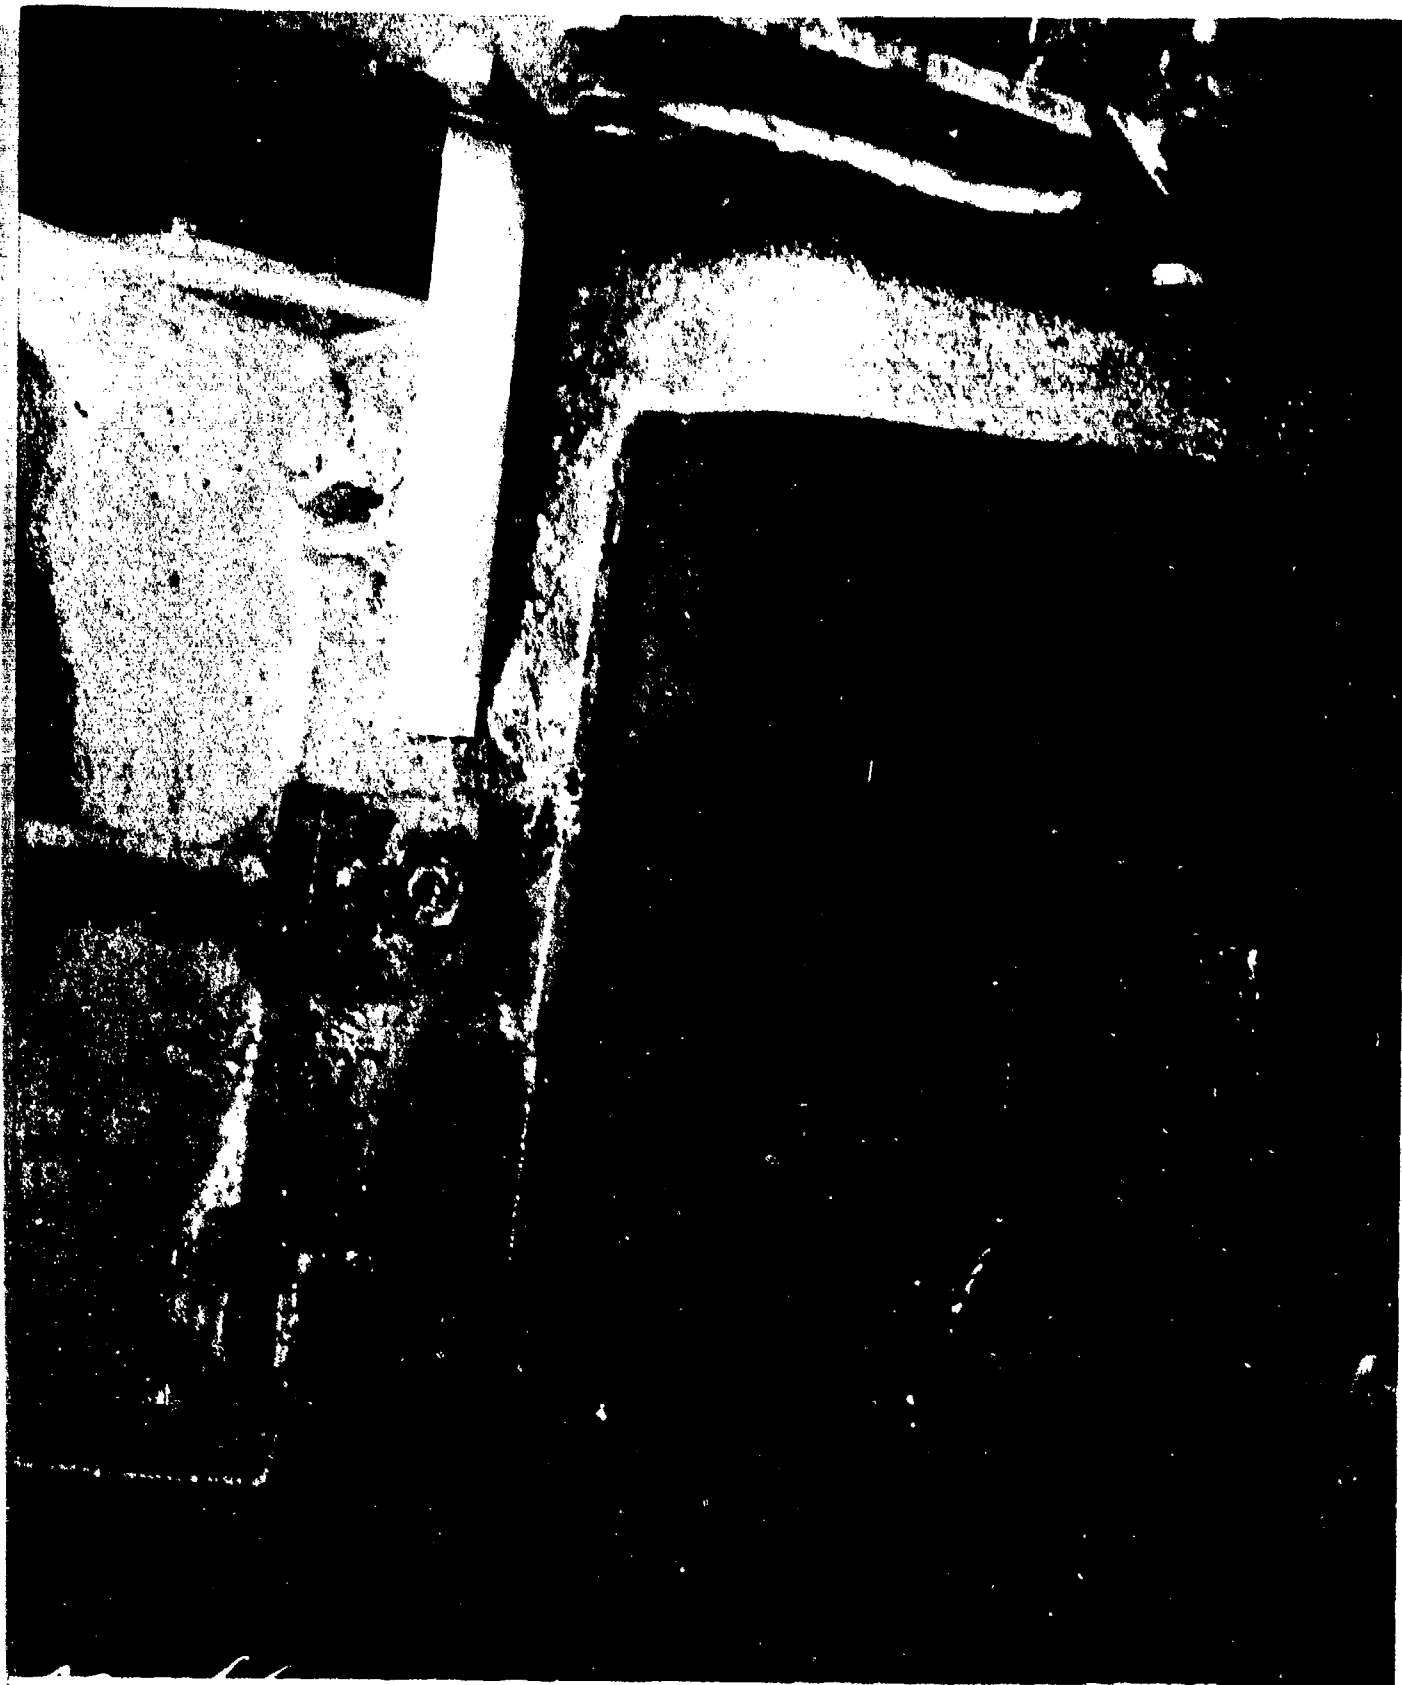
AB-CR-66-157-2. No. 1 spring bearing, starboard shaft.

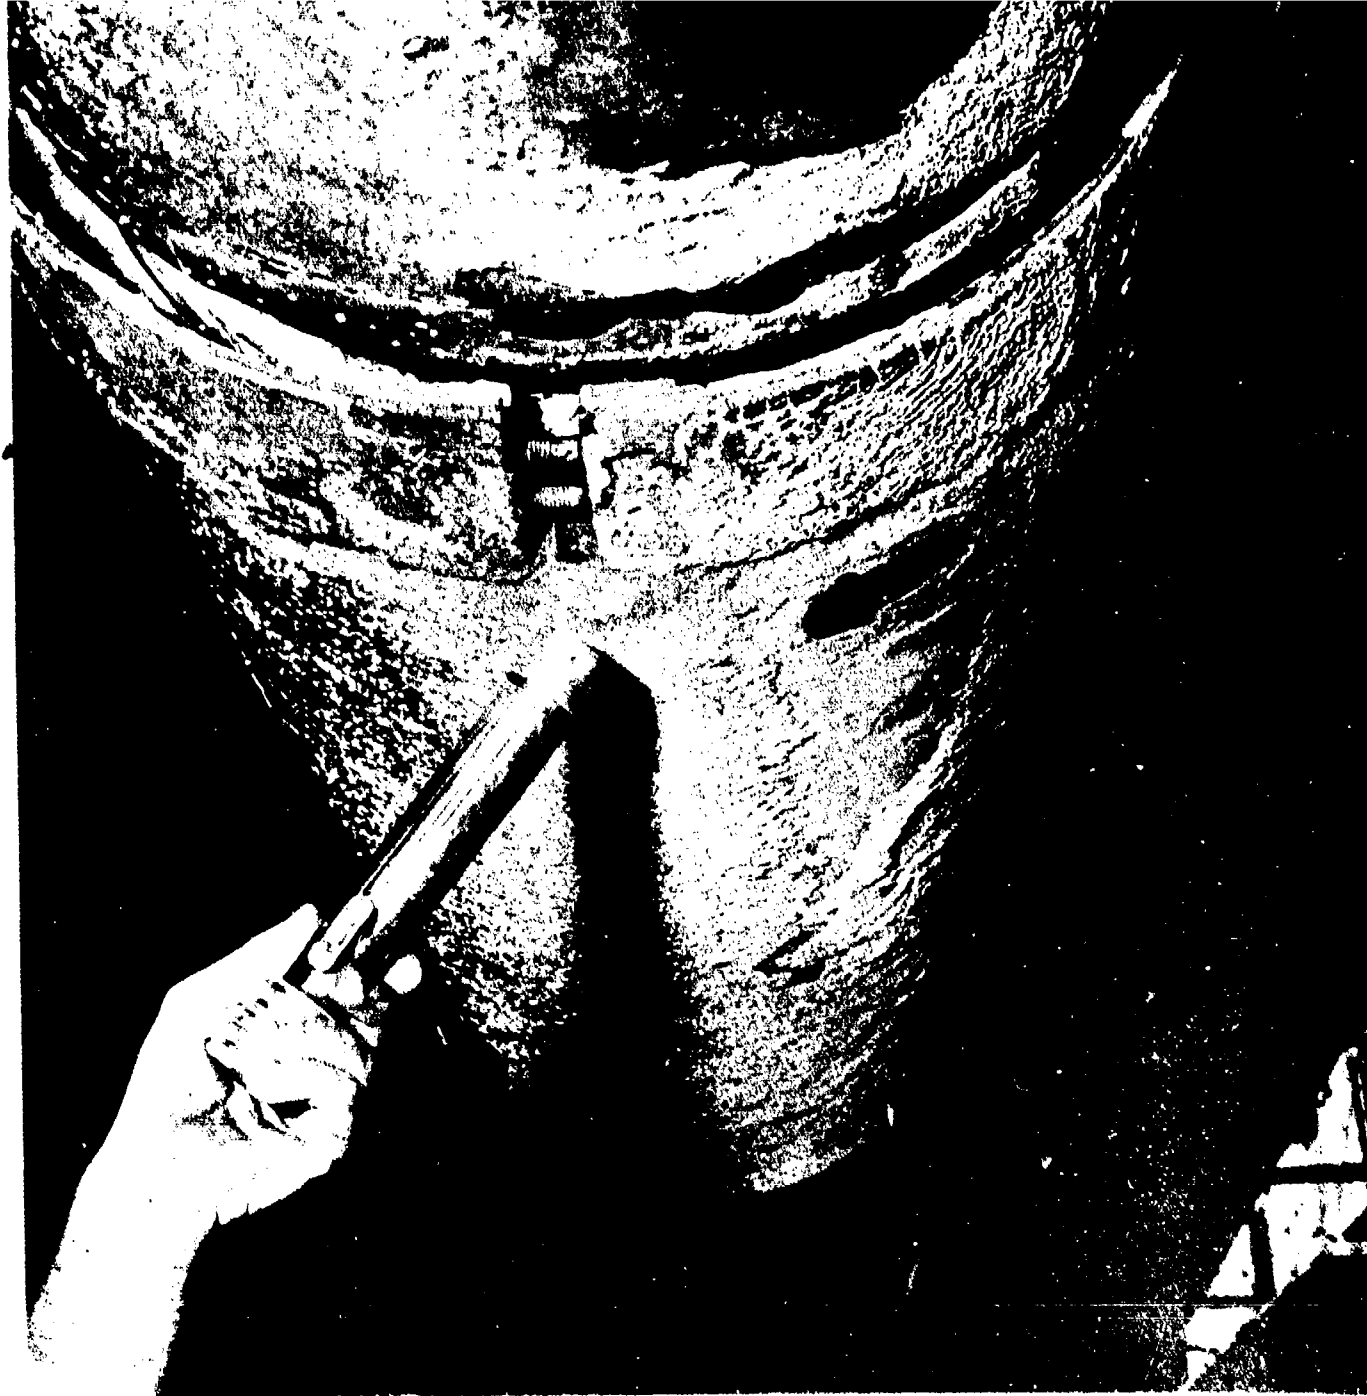
AB-CR-234-4060-5. Starboard intermediate structural fairwater
aft end.

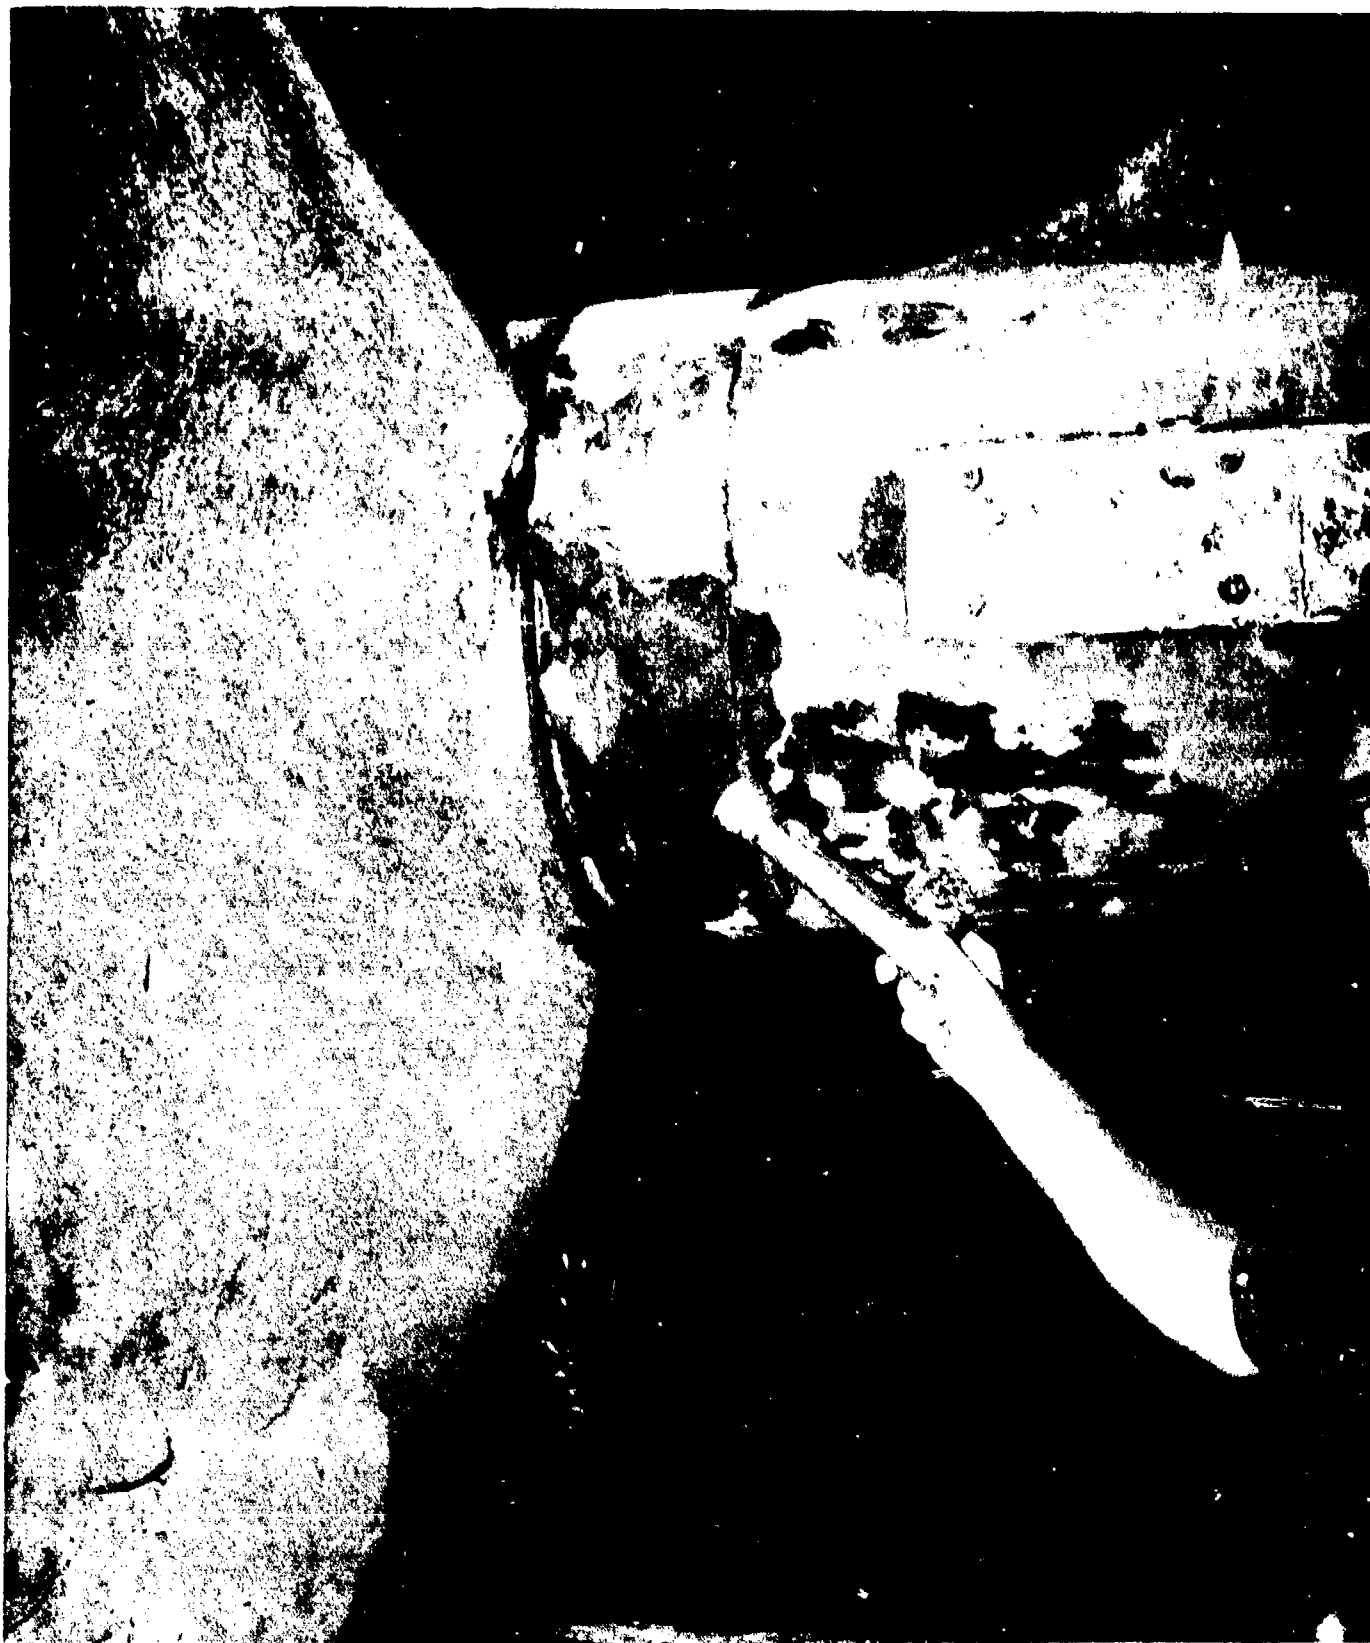
AB-CR-234-4060-6. Starboard rope guard.

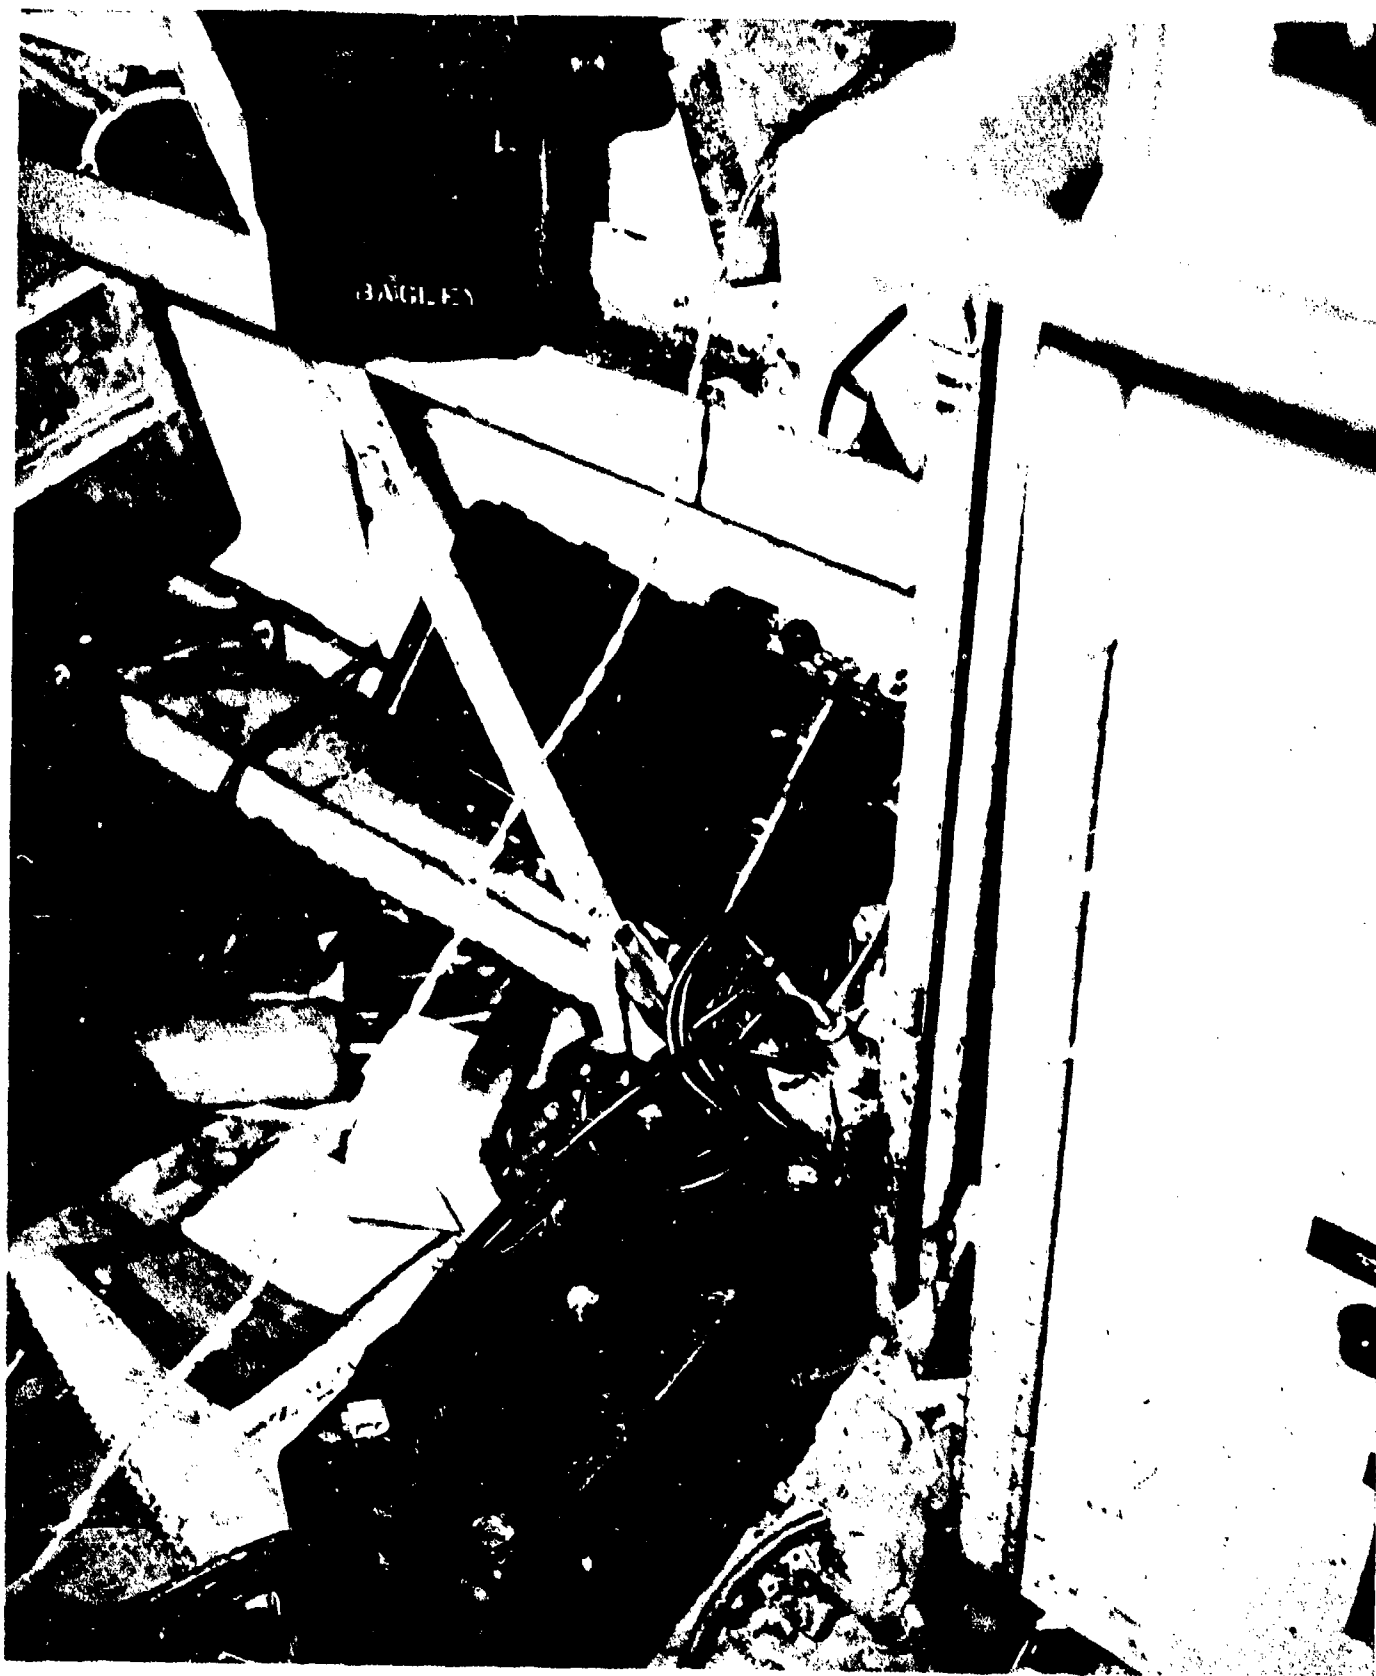
AB-CR-76-1932-12. Storage battery rack in battery charging and electric workshop. Shows batteries dislodged from the battery rack. Picture taken looking towards the port quarter.
